Dovenby bund

April 2023

This project, funded by the North West Regional Flood and Coastal Committee's Slow the Flow funding, involved the construction of an earth bund across the floodplain to store water during high flow events. The bund was built across an existing 1 m diameter culvert within Dovenby Beck, about 800 m upstream of the village. During heavy rainfall the stream flow exceeds the capacity of the culvert and water spills onto the surrounding field. Before the bund was constructed, this water travelled across the field to re-join the stream further downstream (Figure 1). The bund now holds the water back during the rainfall event and is landscaped so that the water drains away once the peak flow has passed. The bund has a lowered overspill point at its western side to reduce pressure on the structure if it overtops. A pond was excavated to provide material for construction of the bund and create habitat, and retains water semi-permanently (Figure 2).

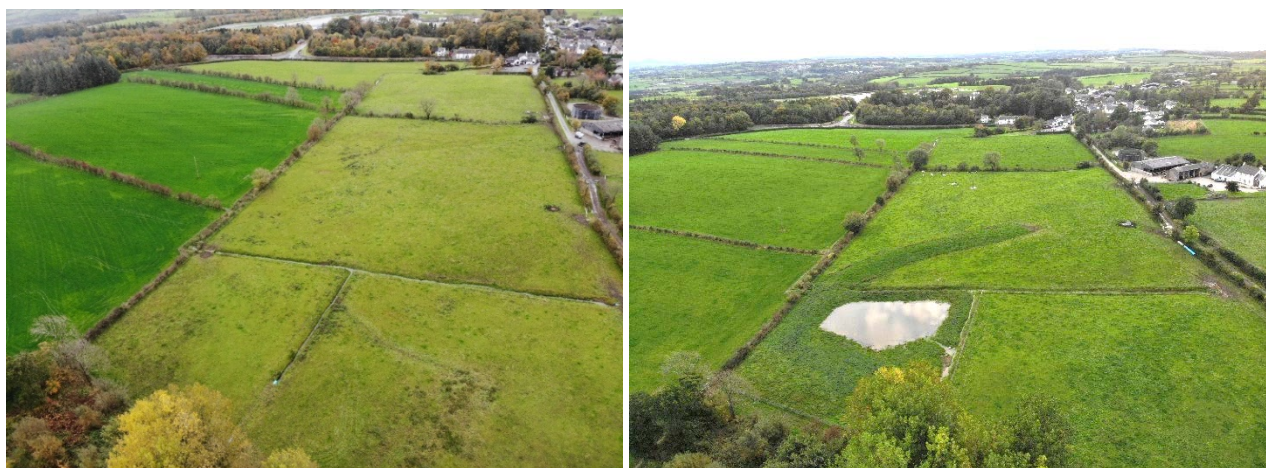
Figure 2 – Dovenby bund, before (left) and after construction (right).

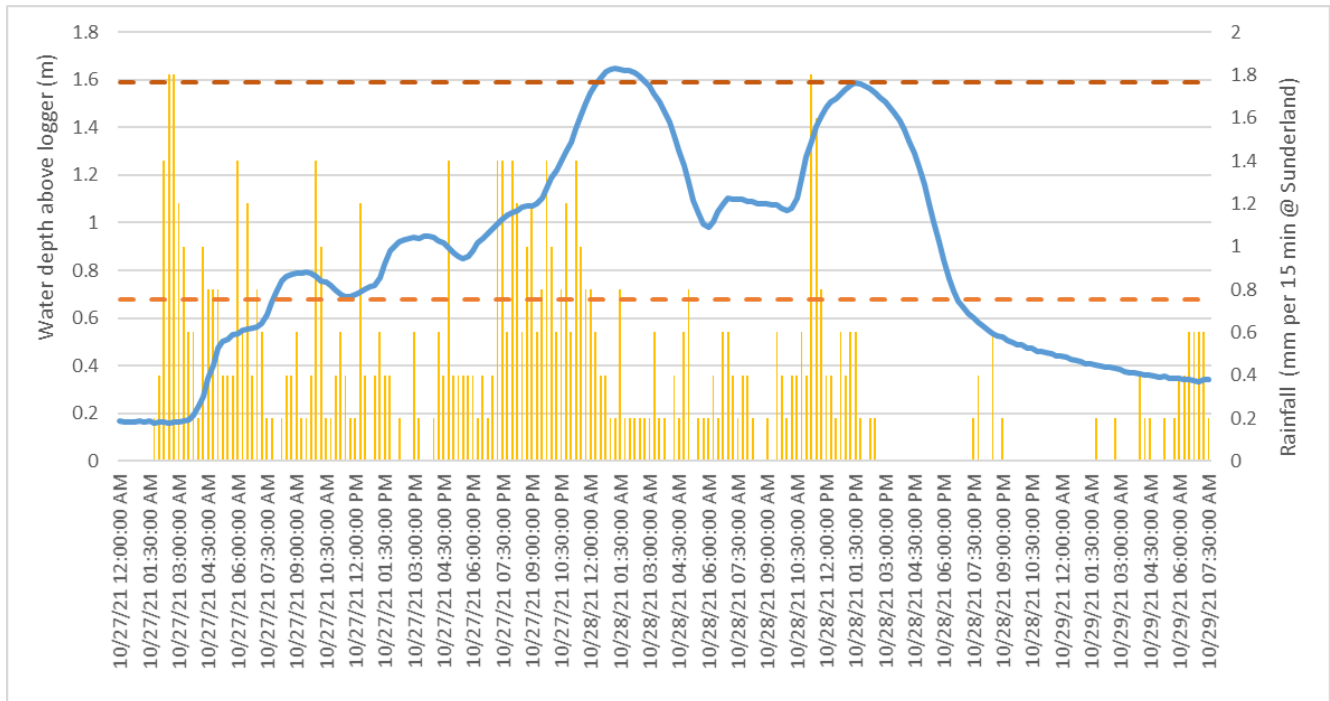
Figure 3 – Water levels within the Dovenby bund during the event on 27th/28th October. The dashed orange line shows the height of the top of the culvert and the red line shows the lowest point on the crest of the bund. Yellow bars show rainfall at Sunderland Environment Agency rain gauge.

During this event, the bund filled gradually between 3 am on 27th October and 2 am on 28th October, reaching 4 cm above the crest of the bund. This provided a maximum storage volume of 1160 m³. The water storage area then drained back to bankfull level before filling rapidly between 10 am and 1.30 pm on 28th October, reaching the bund crest. The bund then drained back to base level within 5 hours (Figure 3 and 4). A video of the bund filling and draining can be viewed [here](#). The water storage in the bund responded to rainfall intensity, filling most rapidly during the highest intensity rainfall and draining when rainfall eased (Figure 3).

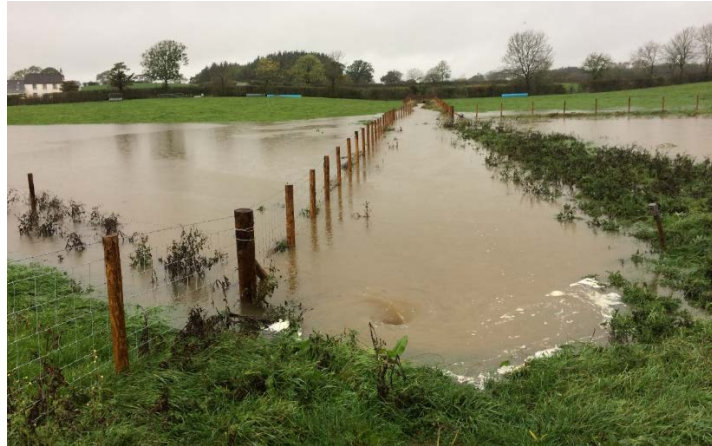
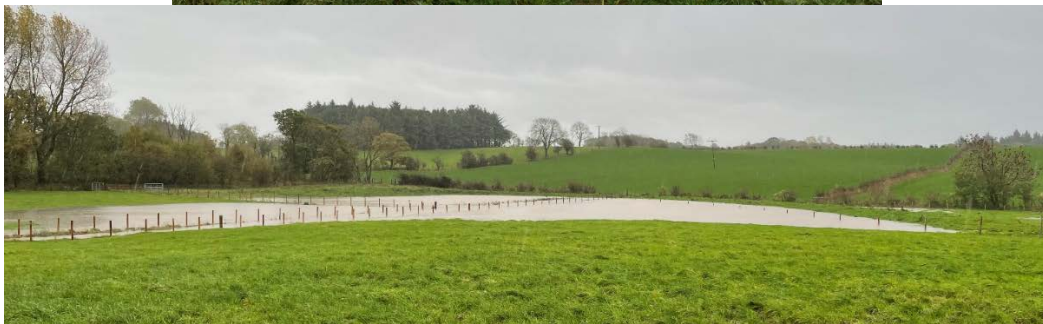
Figure 4 – Bund filling on 28th October 2021

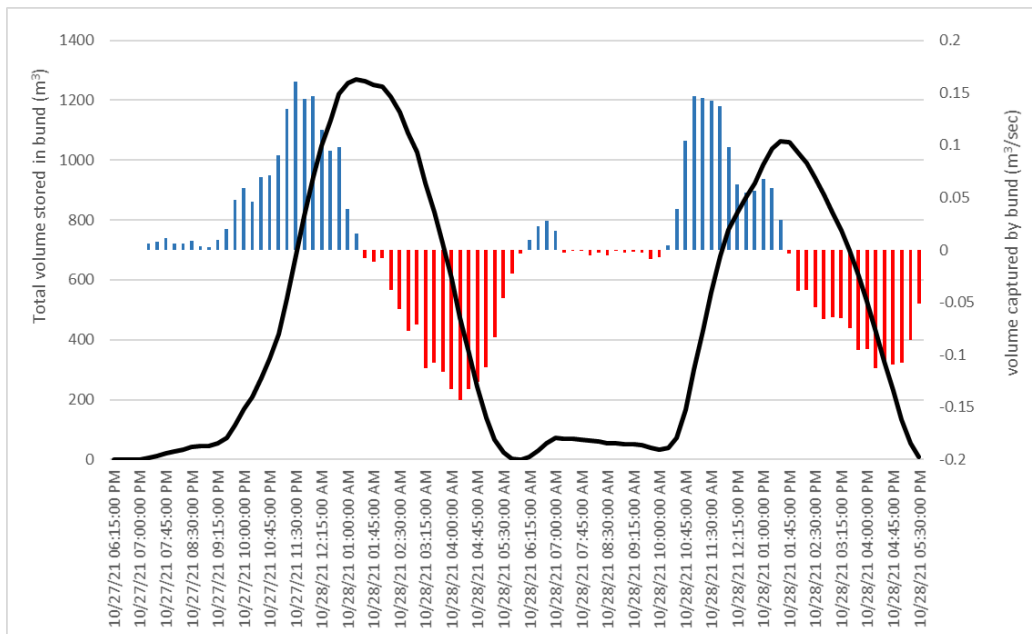
Figure 5 - Volume of water within the Dovenby bund during the high flow event on 27th-28th October 2021 (black line) and change in volume stored over time in cubic meters per second. Positive values (blue) show the feature filling and negative values (red) show the feature draining.

During this event, the water storage area filled at a maximum rate of 144 m³ in 15 minutes. This equates to 0.16 m³/sec. The rate of fill did not change when the overspill level was reached.

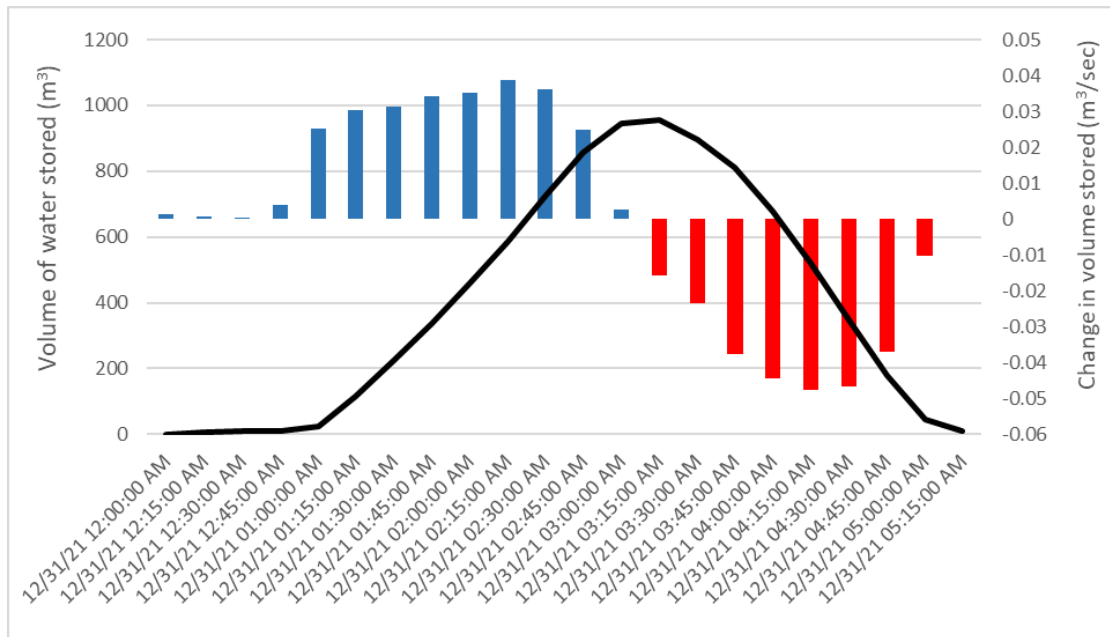
Figure 7 - Volume of water within the Dovenby bund during the high flow event on 31st December 2021 (black line) and change in volume stored over time in cubic meters per second. Positive values (blue) show the feature filling and negative values (red) show the feature draining.

The water level within the bund rose to 1.55 m, just below the height of the bund crest (1.59 m). This is a volume of 954 m³. The water storage area filled at a maximum rate of 0.039 m³/sec (Figure 7). Again, the rate of fill did not change when the overspill level was reached.

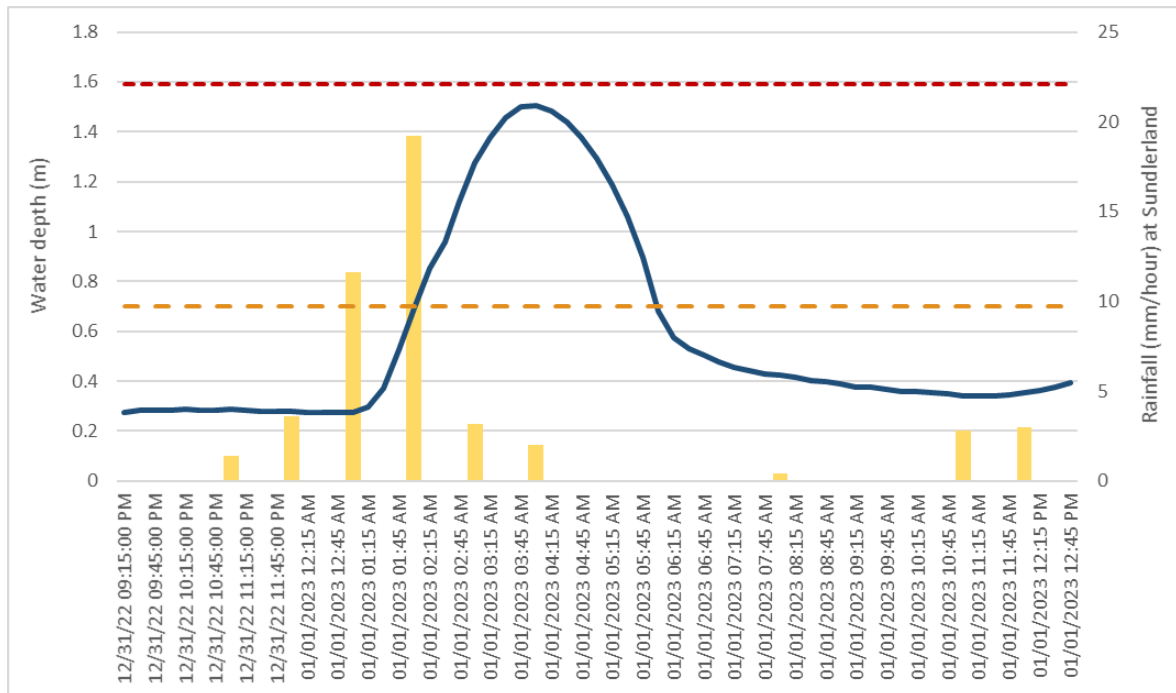
Figure 9 – Water depth in the Dovenby bund and rainfall on 31st December 2022 to 1st January 2023. The dashed orange line shows the height of the top of the culvert and the red line shows the lowest point on the crest of the bund. Yellow bars show rainfall at Sunderland Environment Agency rain gauge.

On 1st January 2023, there was a short but very intense rainfall event, with 41 mm of rainfall falling in six hours and a maximum intensity of 19.2 mm within an hour. During this event, the bund filled to 1.5 m. This is above the overspill height (1.32m) but below the crest of the bund (1.59m) (Figure 9).
